HA-1976

US 40 over Otter Point Creek (Wenters Run)

MARYLAND INVENTORY OF HISTORIC BRIDGES
HISTORIC BRIDGE INVENTORY
MARYLAND STATE HIGHWAY ADMINISTRATION/
MARYLAND HISTORICAL TRUST

SHA Bridge No. 12028 Bridge name US 40 over Otter Point Creek

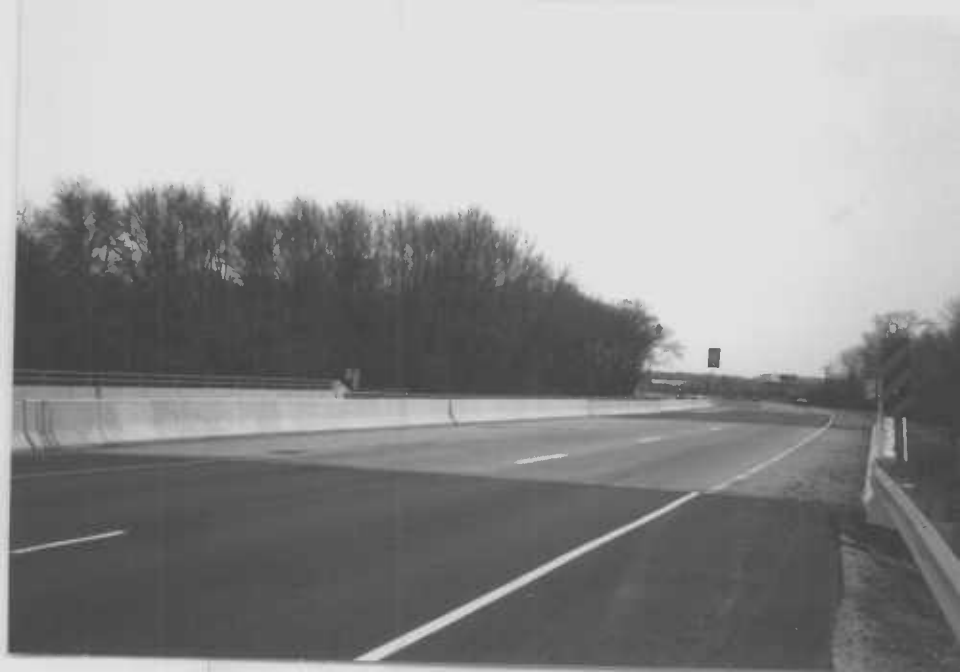
8. 2 of 6

7. roadway approach

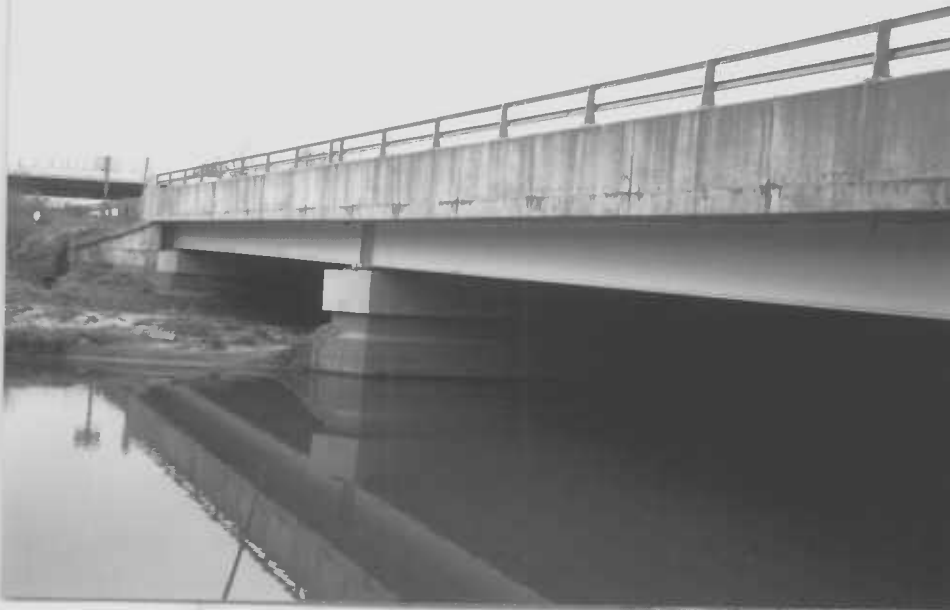
1. HP-1976 over point creek
2. US 4C over Winter Run }
3. Hazard Co MD
4. Caroline Hall
5. 3/97
6. MD SHPO
7. detail of substructure
8. 6 of 6

According to the 1996 inspection report, this structure was in satisfactory condition with light rust on the bottom flanges of the girders. The abutments, pier and wing walls have vertical cracking with efflorescence and concrete erosion at the water line. Both parapets have longitudinal cracks and peeling paint and the metal railings have no defects.
